CASE STUDY

SCVF Remediation with VentMeter™ Technology

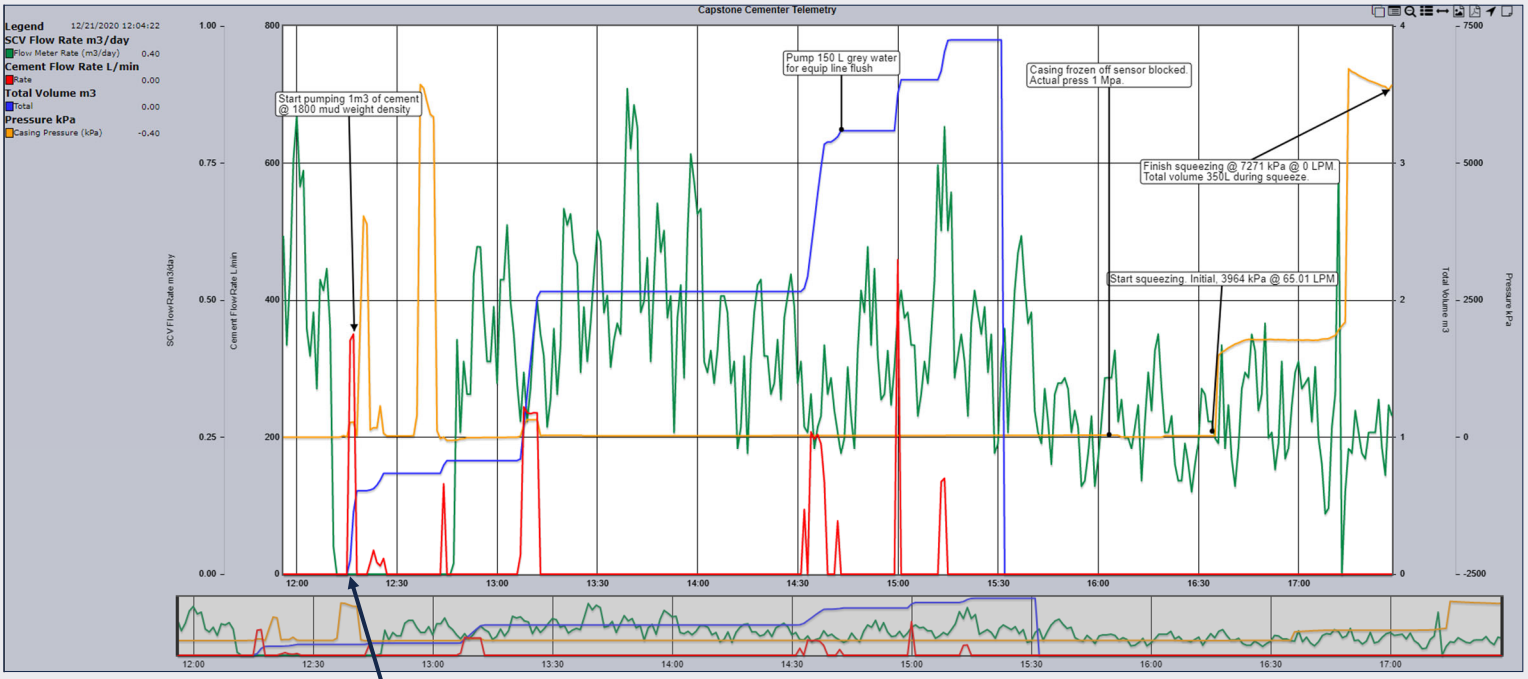
At this point of cement to perforations, a change in surface casing vent flow is seen, that would not have been seen on a traditional bubble test

Rig, cementer pump & pressure data correlated with VentMeter™ SCVF data for confident, precise, real-time decision making during remedial operations.
